Crooked Lake Outlet Structure Replacement

Technical Proposal

Revision 1

A03242C02

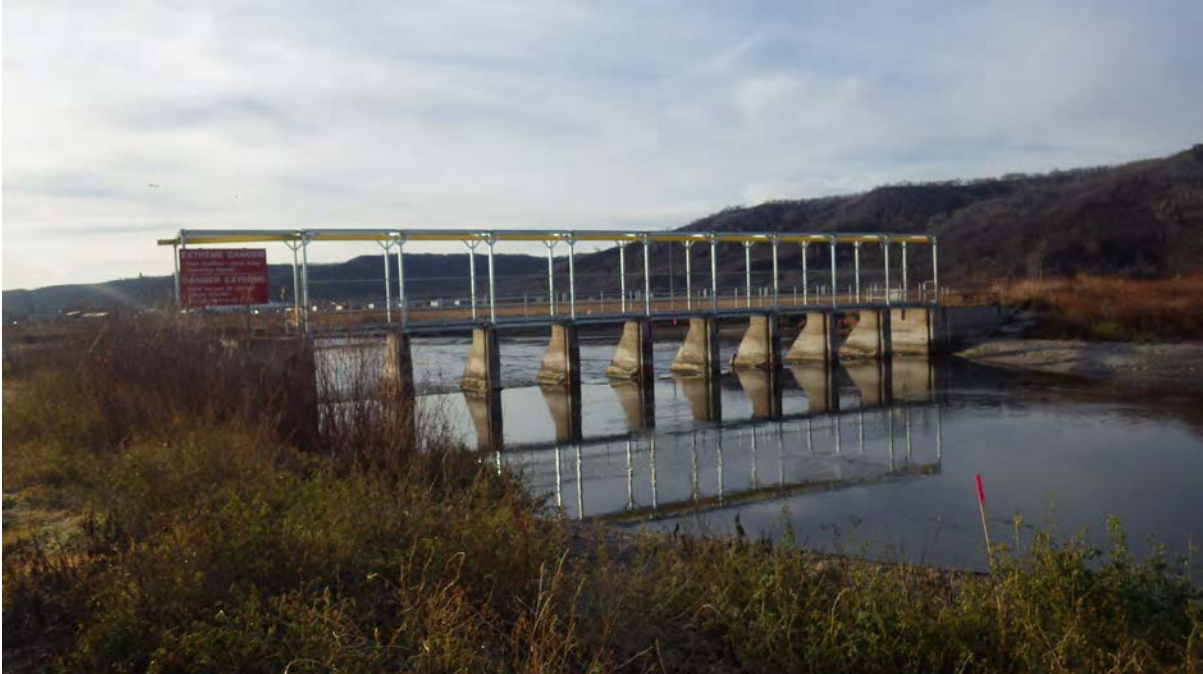
Figure 3: The current Crooked Lake outlet structure, view south

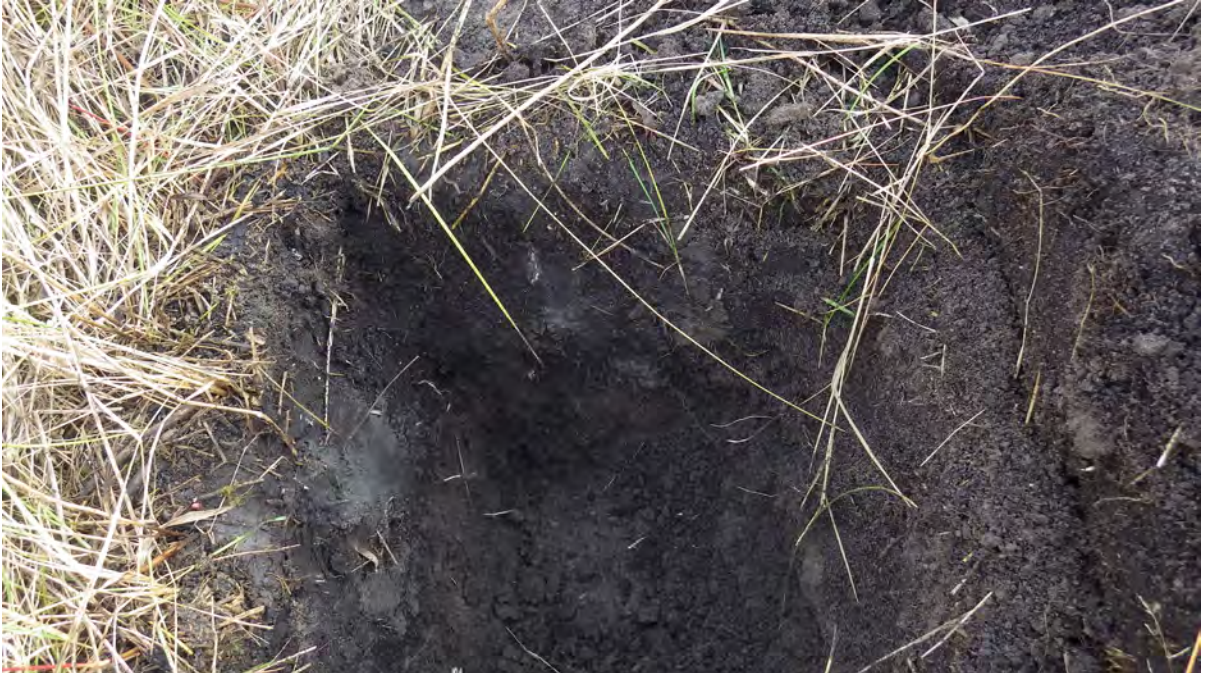
Figure 8: Sediment profile of shovel tests excavated in the cultivated field

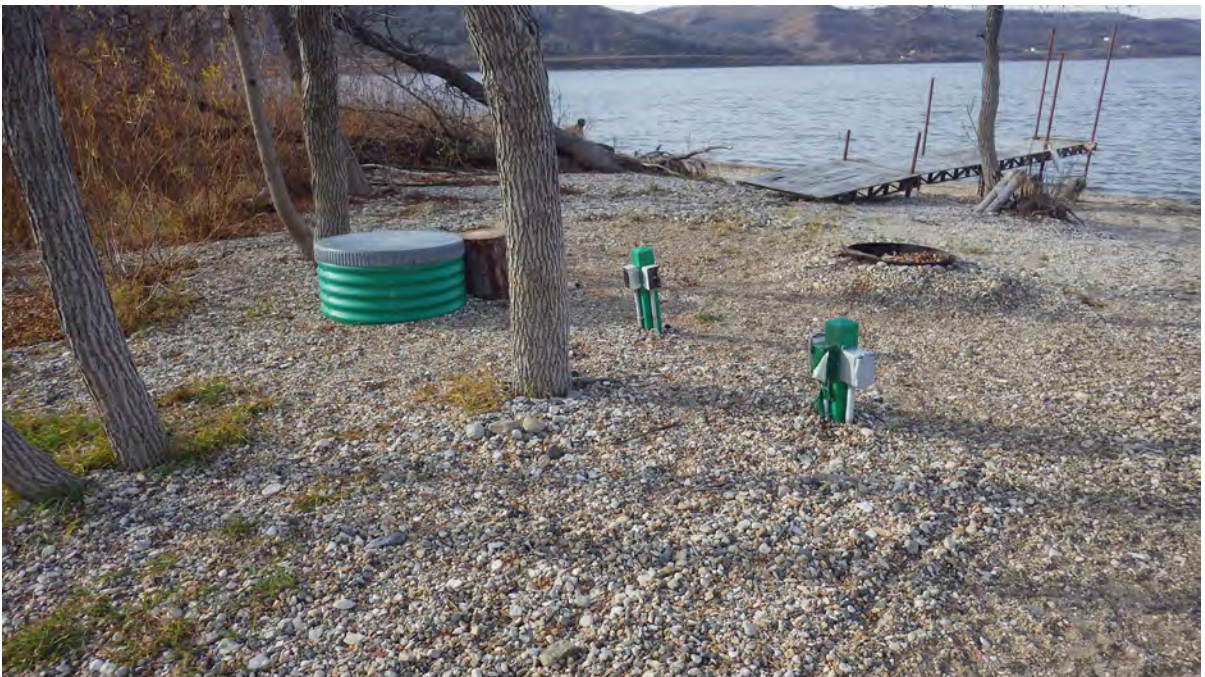
Figure 14: Electrical infrastructure near the cleared area

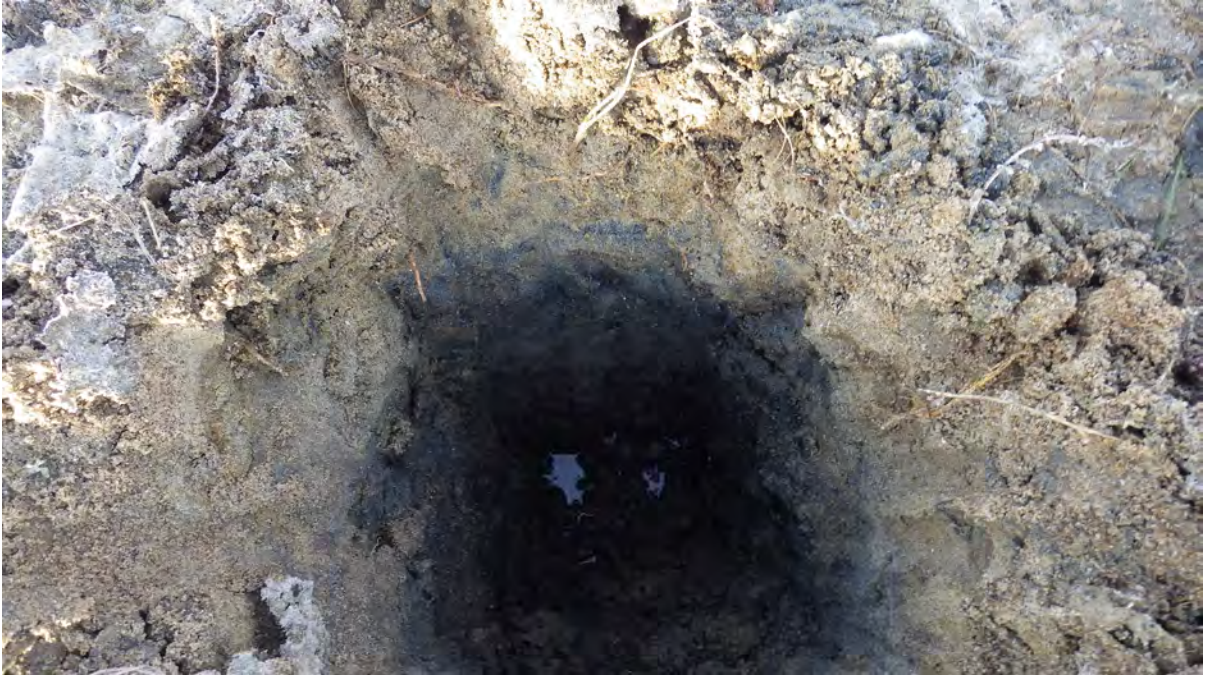
Figure 17: Profile of shovel tests on the sand/gravel bar

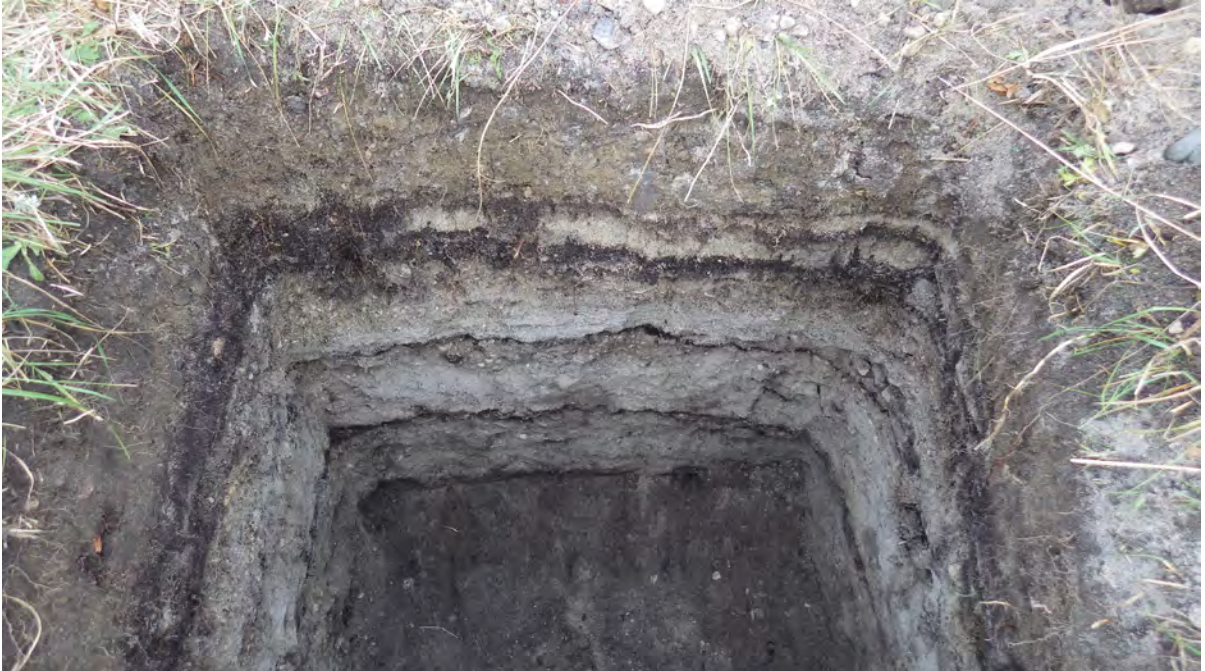
Figure 20: Profile of the deep test excavated in the eastern polygon

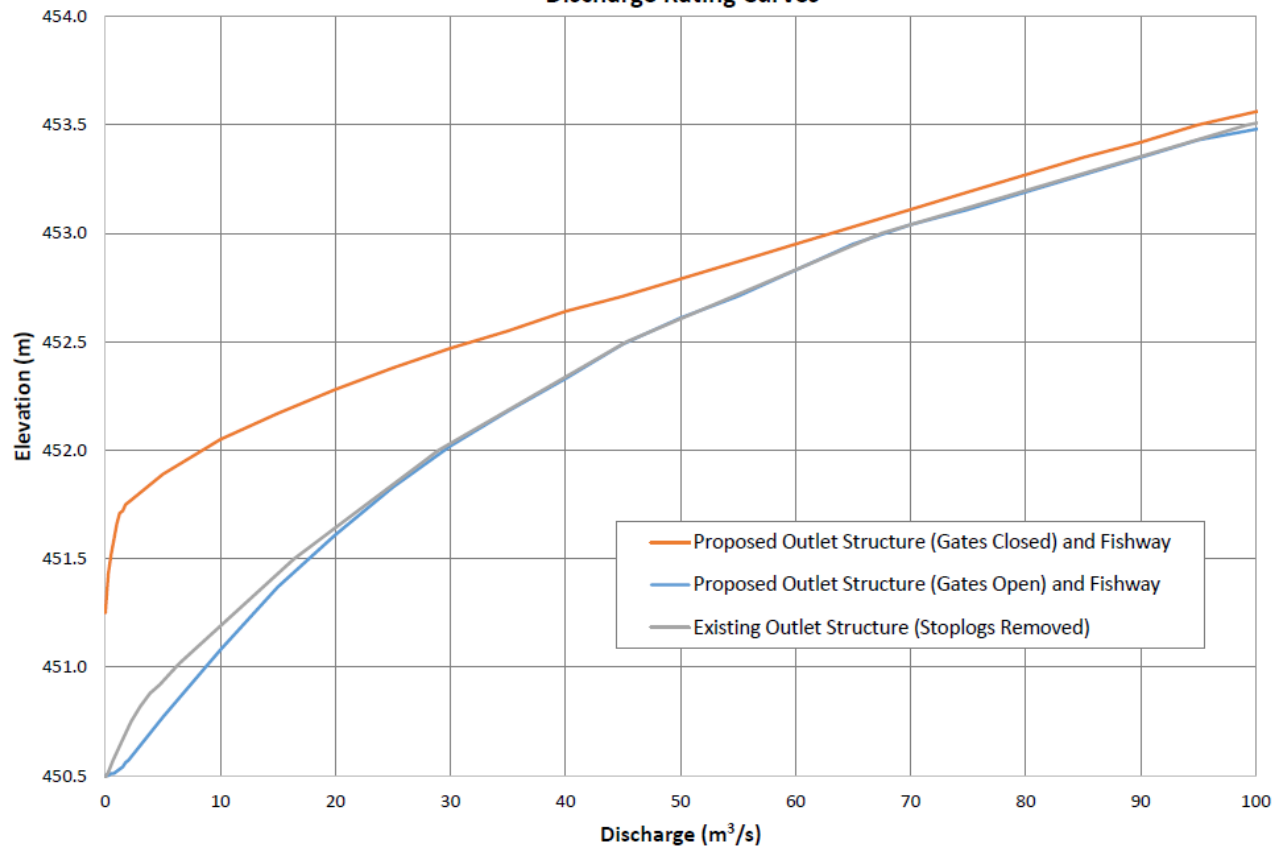
Figure 6.18
Crooked Lake Existing and Proposed Outlet Structures
Discharge Rating Curves
